# PACOPATCH DATASHEET

**Pacopatch** is a revolutionary, polymer based, bituminous repair system developed for the reinstatement of failing ironwork in asphalt or concrete pavements. Producing a permanent repair, Pacopatch is a 100% on-site process and requires no subsequent maintenance.

# PACOPATCH INSTALLATION PROCESS

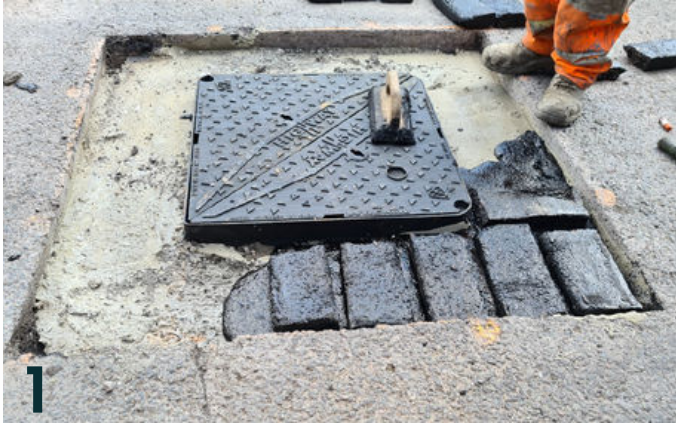
**1** Break out and replace the existing ironwork and bed in rapid-set mortar. Infill with hot polymer-modified mastic asphalt.

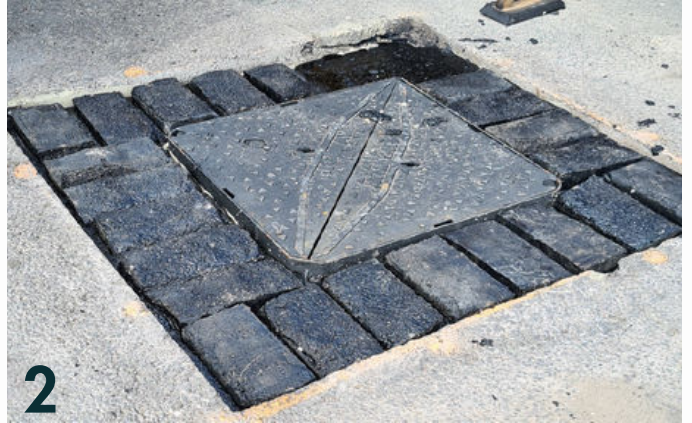
**2** Cold mono-polymer bricks are laid to cool the hot mastic asphalt and provide structural ability.

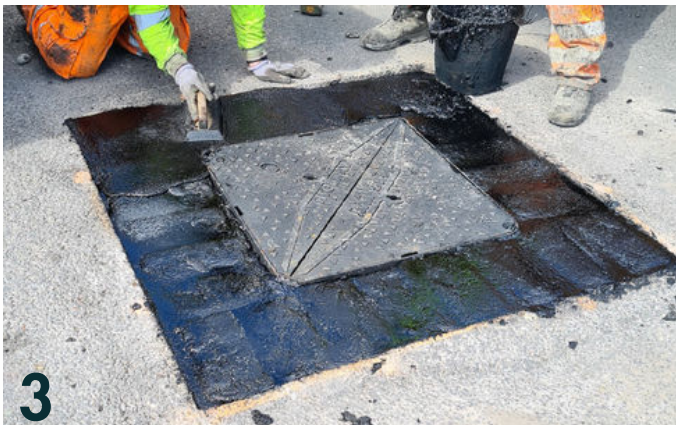
**3** Additional mastic asphalt is applied to fill the voids and create a monolithic structure. The surface is hand levelled.

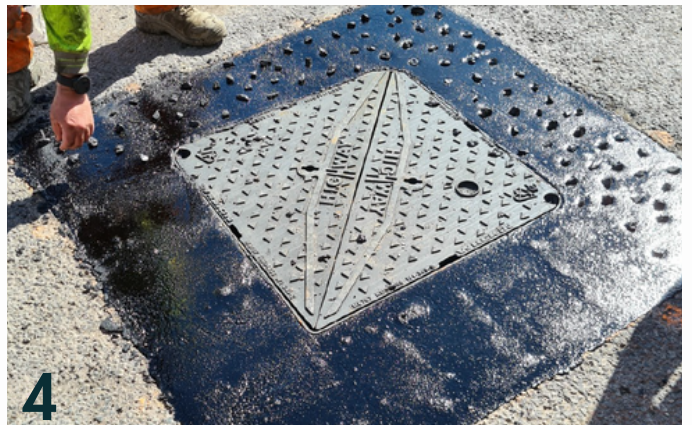
**4** Pre-coated asphalt chippings are embedded in the surface of the mastic-asphalt creating a positive surface texture and skid resistance.

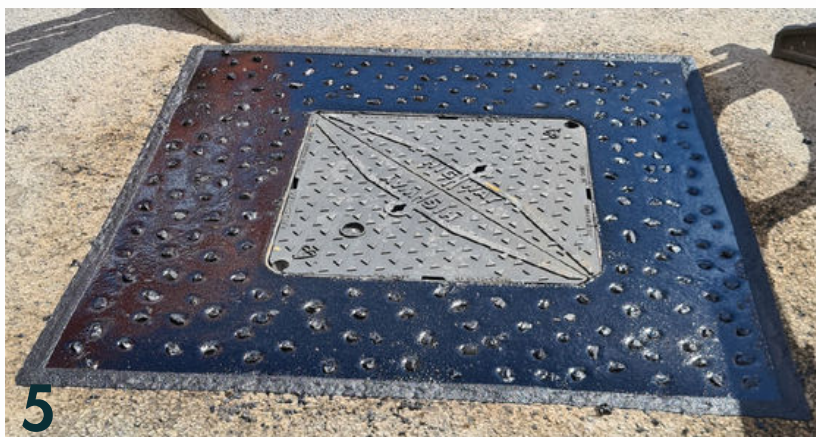
**5** Finally, overbanding is applied.

The result is a highly durable and impermeable reinstatement solution that excels on heavy-duty applications.
