Pacopatch is a revolutionary, polymer based, bituminous repair system developed for the reinstatement of failing ironwork in asphalt or concrete pavements. Producing a permanent repair, Pacopatch is a 100% on-site process and requires no subsequent maintenance.

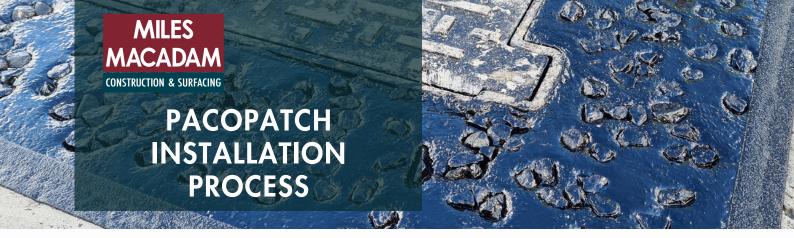
Break out and replace the existing ironwork and bed in rapid-set mortar. Infill with hot polymer-modified mastic asphalt.

Cold mono-polymer bricks are laid to cool the hot mastic asphalt and provide structural ability.

Additional mastic asphalt is applied to fill the voids and create a monolithic structure. The surface is hand levelled.

Pre-coated asphalt chippings are embedded in the surface of the mastic-asphalt creating a positive surface texture and skid resistance.

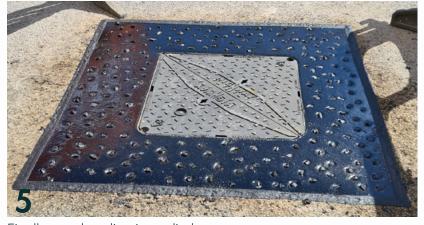
Finally, overbanding is applied.

The result is a highly durable and impermeable reinstatement solution that excels on heavy-duty applications.
